**Flood Control Project Maintenance
Levee Inspections**

Fall 2016 Levee Maintenance Deficiency Summary Report

San Joaquin River Basin

Reclamation District No. 0404 Boggs

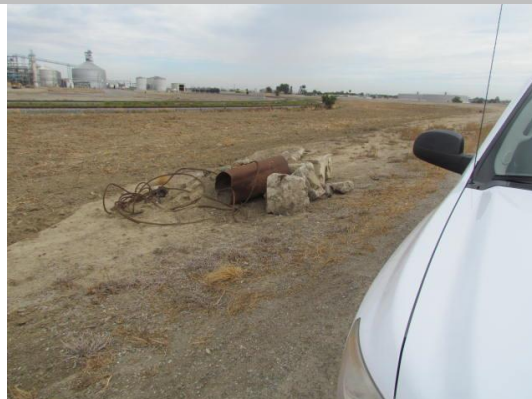
Photo 1 of 1 : FA_2016_RD0404_305_31_20160929_00022.jpg

Looking southeast at concrete blocks on landward slope.

LM Start	0.21	Rating **	C	Issue No.	9
LM End	0.26	Issue Type +	Ma	Location *	WS
Category	Supplemental			GPS Latitude/Longitude	
				Start	End
Item	DWR Erosion Survey			37.939480 °	37.939480 °
				-121.342730 °	-121.342730 °
DWR ID

Comment Code					
Inspector Comment					
07/25/2016: No new erosion observed at the repaired site.					
06/24/2015: The erosion has been repaired.					
06/19/2014: No significant change observed.					
08/13/2013: The boat survey found the erosion has progressed significantly in size and in number of pocket erosions.					
08/07/2012: The site has been visited by boat survey. The erosion has developed in size, and more pocket erosions were found.					
8/23/2011: Pockets erosions observed by last survey seem to have progressed during the last flood season. Continuous monitoring of this site suggested					
9/07/2010: No significant change observed on site. There is emergent vegetation at the water line. Several pocket erosions lined along the lower slope that stretches from RM 40.86 to RM 41.14.					
9/30/2009: No major change observed; the site was combined with other existing sites are RM's 40.93, 40.98, and 41.14 as one site; several pocket erosion just above non-uniform toe rip rap; previously rated "U"; bare spots along the upper slope.

2008: Possibly caused by wave wash erosion; several pocket erosion along the lower slope; site is inside of a bend.					
2006: Visited site 09/12/06. [2016 Site ID:RD0404U01RM40.86]

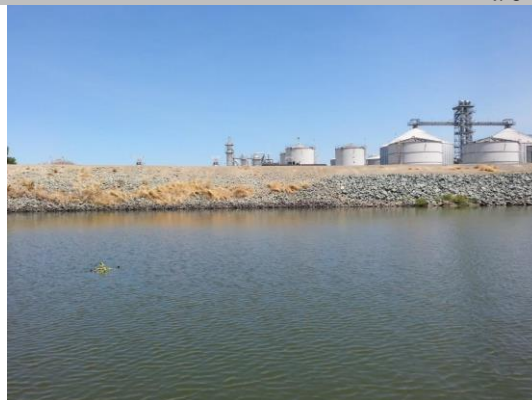
Photo 1 of 2 : SJR2016_RD0404U01RM41.11_1.jpg

LM Start	0.34	Rating **	U	Issue No.	32
LM End	0.34	Issue Type +	Ma	Location *	WS
Category	Supplemental			GPS Latitude/Longitude	
				Start	End
Item	DWR Erosion Survey			37.939190 °	37.939190 °
				-121.338280 °	-121.338280 °
DWR ID					
Comment Code					
Inspector Comment					
07/25/2016: No significant change observed. 06/24/2015: No significant change observed. 06/19/2014: No significant change observed. 08/13/2013: No significant change at this site. 08/7/2012: The erosion is next to a repaired site and approximately 400 feet downstream of a river bend. There are broken concretes at the upper levee slope, but not visible at the levee toe or lower slope. Likely the protection concrete blocks have been washed away. [2016 Site ID:RD0404U01RM41.11]

Front view of the site.

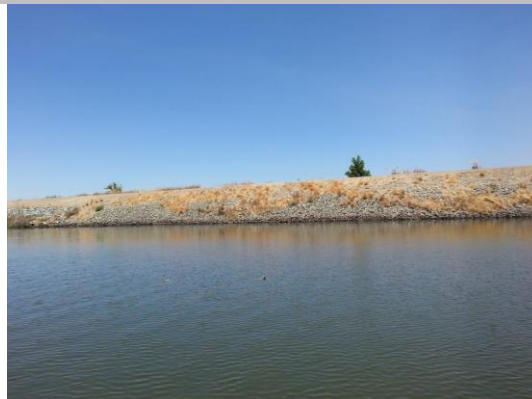
Photo 2 of 2 : SJR2016_RD0404U01RM41.11_2.jpg

LM Start	0.34	Rating **	U	Issue No.	32 (cont)	
LM End	0.34	Issue Type +	Ma	Location *	WS	
Category	Supplemental			GPS Latitude/Longitude		
				Start		End
Item	DWR Erosion Survey			37.939190 °		37.939190 °
				-121.338280 °		-121.338280 °
DWR ID						
Comment Code						
Inspector Comment						
07/25/2016: No significant change observed. 06/24/2015: No significant change observed. 06/19/2014: No significant change observed. 08/13/2013: No significant change at this site. 08/7/2012: The erosion is next to a repaired site and approximately 400 feet downstream of a river bend. There are broken concretes at the upper levee slope, but not visible at the levee toe or lower slope. Likely the protection concrete blocks have been washed away. [2016 Site ID:RD0404U01RM41.11]

Front view of the site.

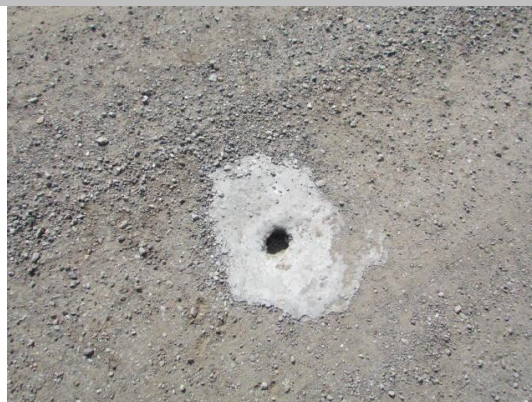
Photo 1 of 4 : FA_2016_RD0404_305_5_20160929_00004.jpg

LM Start	0.43	Rating **	M	Issue No.	5
LM End	0.43	Issue Type +	Ma	Location *	CR
Category	Earthen Levee			GPS Latitude/Longitude	
				Start	End
Item	Animal Control			37.939635 °	37.939635 °
				-121.339063 °	-121.339063 °
DWR ID	DWR_RD0404_01_s_2013_5				
Comment Code					
A3 : No rodents visible, but rodent burrows visible; need to backfill and compact or grout burrows.					
Inspector Comment					
District grouted hole, and the deficiency still exist.

Looking at partialled grouted rodent hole on levee crown (Fall 2014).

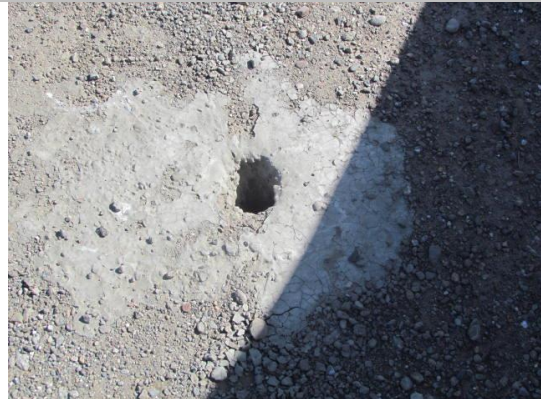
Photo 2 of 4 : FA_2016_RD0404_305_5_20160929_00005.jpg

Looking at partially grouted rodent hole on levee crown

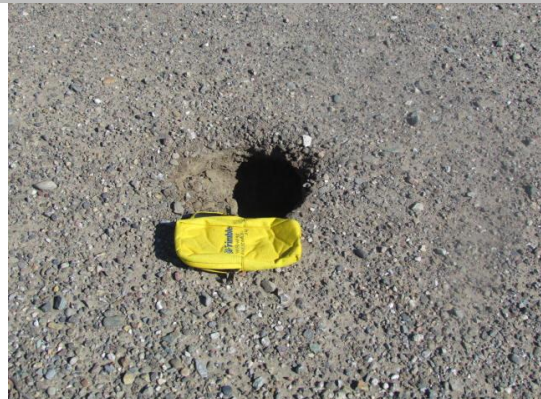
Photo 3 of 4 : FA_2016_RD0404_305_5_20160929_00006.jpg

Looking at rodent hole on levee crown.

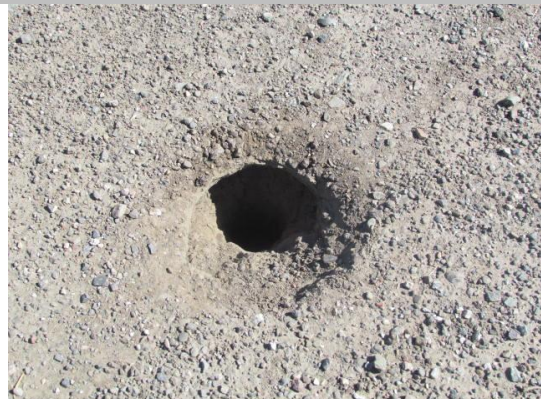
Photo 4 of 4 : FA_2016_RD0404_305_5_20160929_00007.jpg

Looking at one of several rodent holes on levee crown.

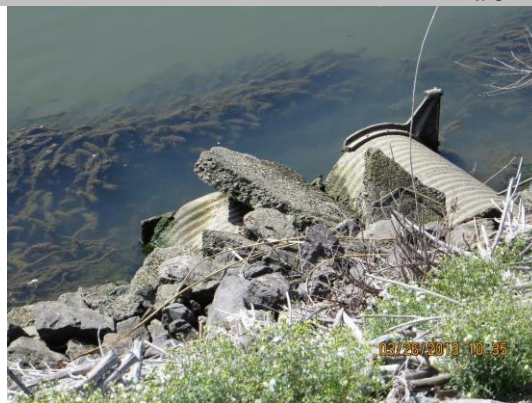
Photo 1 of 2 : UCIP_FA_2016_40783_20082.jpg

LM Start	0.48	Rating **	U	Issue No.	111
LM End	0.48	Issue Type +	En	Location *	WS
Category	Supplemental			GPS Latitude/Longitude	
				Start	End
Item	DWR UCIP Field Study			37.939640 °	37.939640 °
				-121.338175 °	-121.338175 °
DWR ID					
Comment Code					
Inspector Comment					
FS_ID:40783					
DS_ID:22968					
EP_NO: N/A					
Repair Type: Urgent					
Crossing Status: Found					
UCIP Comments: Flap gate missing from WS toe.					
FIELD_STRUCT_DESC: 1 of 2. Two 36-inch corrugated metal drainage pipes.					
FS Date: 3/26/2013

WS- two CM pipes with damaged flap gates

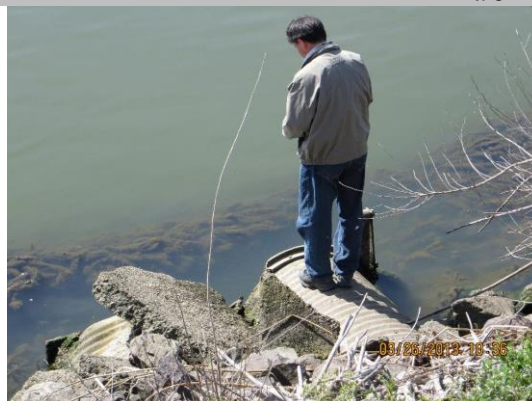
Photo 2 of 2 : UCIP_FA_2016_40783_20081.jpg

LM Start	0.48	Rating **	U	Issue No.	111 (cont)	
LM End	0.48	Issue Type +	En	Location *	WS	
Category	Supplemental			GPS Latitude/Longitude		
				Start		End
Item	DWR UCIP Field Study			37.939640 °		37.939640 °
				-121.338175 °		-121.338175 °
DWR ID						
Comment Code						
Inspector Comment						
FS_ID:40783						
DS_ID:22968						
EP_NO: N/A						
Repair Type: Urgent						
Crossing Status: Found						
UCIP Comments: Flap gate missing from WS toe.						
FIELD_STRUCT_DESC: 1 of 2. Two 36-inch corrugated metal drainage pipes.						
FS Date: 3/26/2013

WS- left CM pipe with missing flap gate

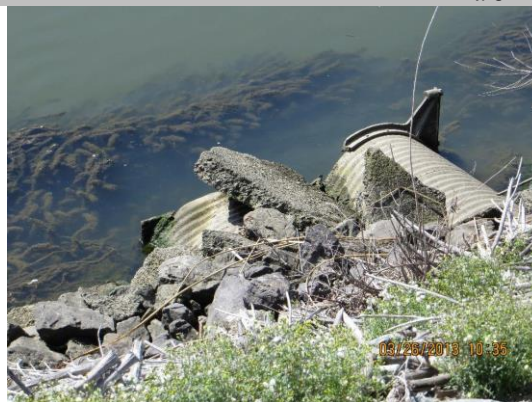
Photo 1 of 2 : UCIP_FA_2016_40784_20086.jpg

LM Start	0.48	Rating **	U	Issue No.	112
LM End	0.48	Issue Type +	En	Location *	WS
Category	Supplemental			GPS Latitude/Longitude	
				Start	End
Item	DWR UCIP Field Study			37.939640 °	37.939640 °
				-121.338175 °	-121.338175 °
DWR ID					
Comment Code					
Inspector Comment					
FS_ID:40784					
DS_ID:22969					
EP_NO: N/A					
Repair Type: Urgent					
Crossing Status: Found					
UCIP Comments: Pipe has broken flap gate.					
FIELD_STRUCT_DESC: 2 of 2. Two 36-inch corrugated metal drainage pipes.					
FS Date: 3/26/2013

WS- two CM pipes with damaged flap gates

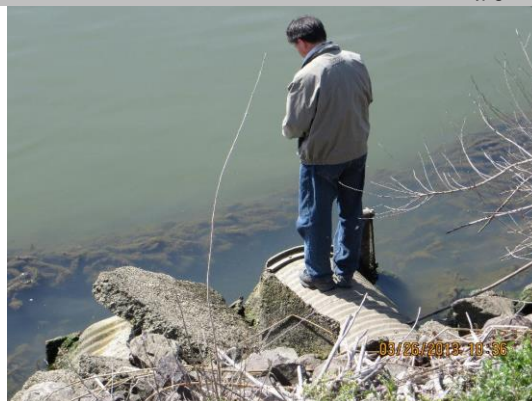
Photo 2 of 2 : UCIP_FA_2016_40784_20085.jpg

LM Start	0.48	Rating **	U	Issue No.	112 (cont)	
LM End	0.48	Issue Type +	En	Location *	WS	
Category	Supplemental			GPS Latitude/Longitude		
				Start		End
Item	DWR UCIP Field Study			37.939640 °		37.939640 °
				-121.338175 °		-121.338175 °
DWR ID						
Comment Code						
Inspector Comment						
FS_ID:40784						
DS_ID:22969						
EP_NO: N/A						
Repair Type: Urgent						
Crossing Status: Found						
UCIP Comments: Pipe has broken flap gate.						
FIELD_STRUCT_DESC: 2 of 2. Two 36-inch corrugated metal drainage pipes.						
FS Date: 3/26/2013

WS- right CM pipe with damaged flap gate

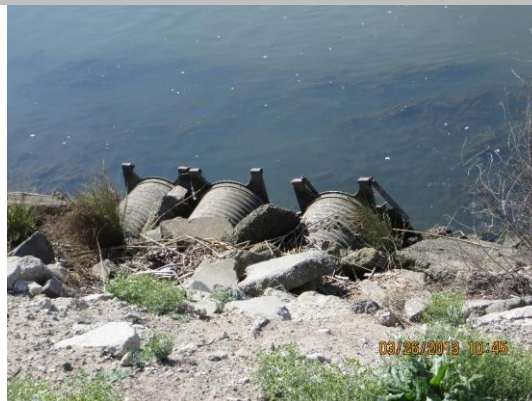
Photo 2 of 2 : UCIP_FA_2016_12383_20046.jpg

FS_ID:12383
DS_ID:18811
EP_NO: N/A
Repair Type: Non-Urgent
Crossing Status: Found
UCIP Comments: Steel intake structure on LS
FIELD_STRUCT_DESC: 3 of 3. 30-inch pipes through levee, 22.0 feet below the crown. Waterward end with flap gates. Steel intake structure on landside. Landward end filled with dirt. Middle flap gate missing and right flap gate broken as of 1/24/07.
FS Date: 3/26/2013

WS- CM pipes and damaged flap gates

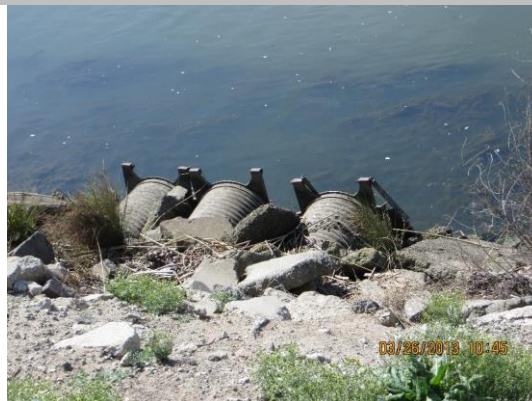
Photo 2 of 2 : UCIP_FA_2016_12384_20053.jpg

FS_ID:12384
DS_ID:18810
EP_NO: N/A
Repair Type: Non-Urgent
Crossing Status: Found
UCIP Comments: Steel intake structure on LS.
FIELD_STRUCT_DESC: 1 of 3. 30-inch CM pipes through levee, 22.0 feet below the crown. Waterward end with damaged flap gates. Steel intake structure on landside. On waterside, middle flap gate missing and right flap gate broken as of 1/24/07.
FS Date: 3/26/2013

WS- CM pipes with damaged flap gates

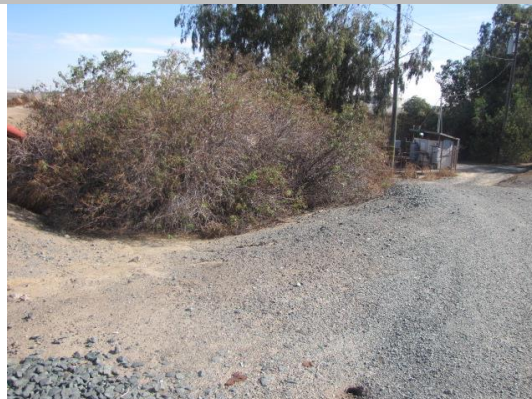
Photo 1 of 1 : FA_2016_RD0404_305_7_20160929_00008.jpg

Looking southeast at elderberry on landside slope.

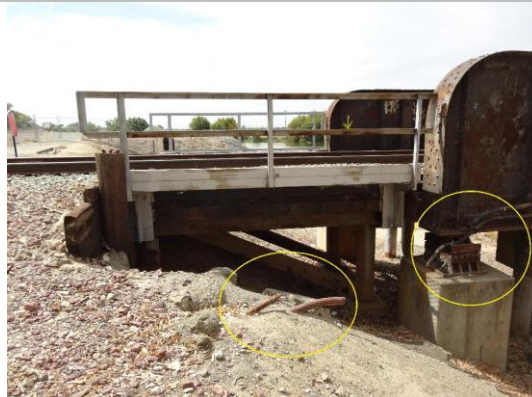
Photo 1 of 2 : UCIP_FA_2016_46810_74753.jpg

FS_ID:46810
DS_ID:17946
EP_NO: N/A
Repair Type: Non-Urgent
Crossing Status: Found
UCIP Comments: Appears abandoned; if so should be done so properly.
FIELD_STRUCT_DESC: Underground telephone cable through levee and across channel. Non-operational.
FS Date: 8/4/2015

WS view looking south: conduits penetrating levee slope now disconnected with those attached to bridge

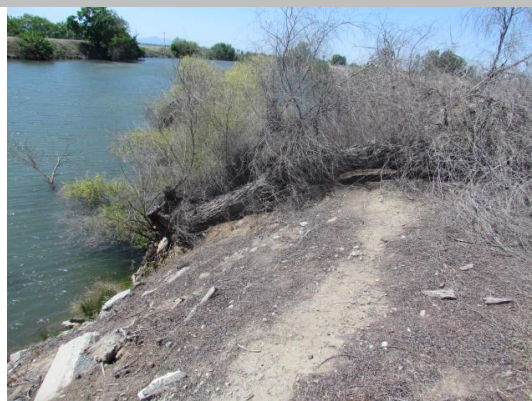
Photo 1 of 2 : FA_2016_RD0404_305_3_20160929_00001.jpg

Looking northwest at downed tree on waterward slope and shoulder.

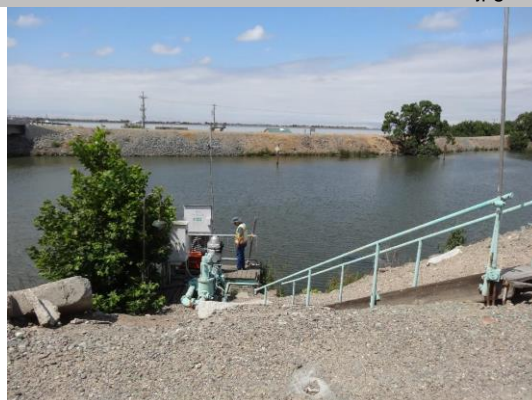
Photo 2 of 2 : UCIP_FA_2016_46801_74747.jpg

WS view: pump with shutoff valves, headwall, stairs visible. Concrete debris along WS slope.

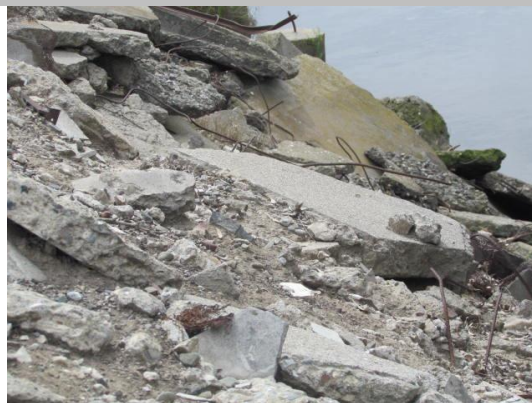
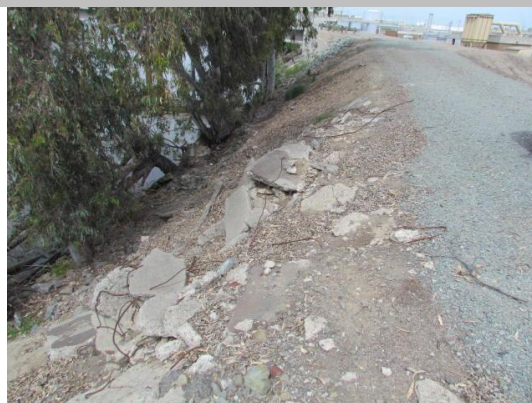
Looking southwest at concrete rubble with rebar on waterward slope.

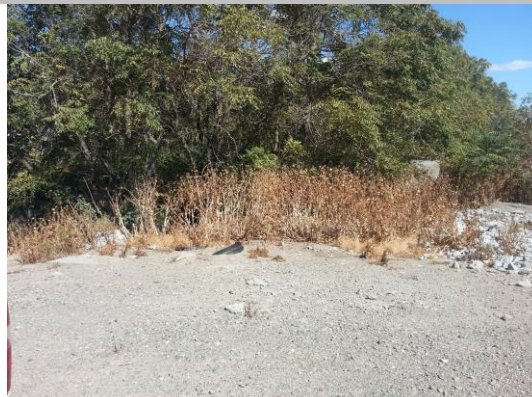
Photo 1 of 2 : FA_2016_RD0404_305_101_20161007_00067.jpg

Looking east at dense vegetation on landward slope. (Fall 2016)

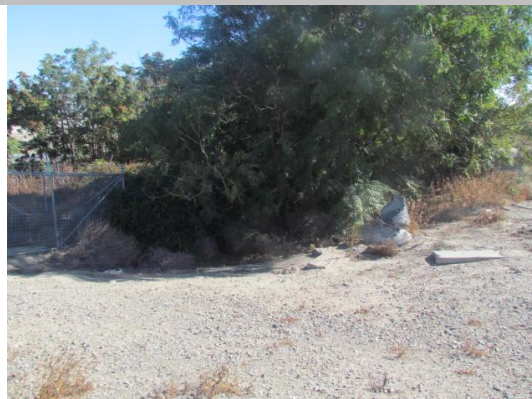
Photo 2 of 2 : FA_2016_RD0404_305_101_20160929_00031.jpg

Looking southeast at overhanging trees on landside slope. (Fall 2015)

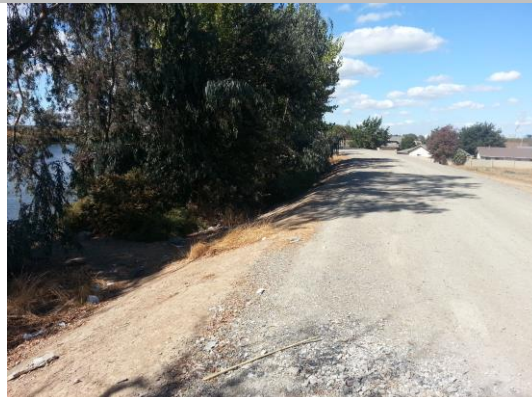
Photo 1 of 1 : FA_2016_RD0404_305_100_20161007_00068.jpg

Looking northwest at untrimmed trees on waterward slope.

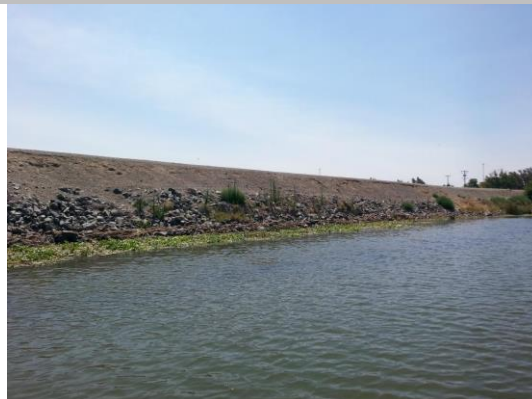
Photo 1 of 2 : SJR2016_RD0404U01RM42.02_1.jpg

LM Start	1.44	Rating **	M	Issue No.	41
LM End	1.46	Issue Type +	Ma	Location *	WS
Category	Supplemental			GPS Latitude/Longitude	
				Start	End
Item	DWR Erosion Survey			37.930450 °	37.930450 °
				-121.327450 °	-121.327450 °
DWR ID					
Comment Code					
Inspector Comment					
07/25/2016: No significant change observed.					
06/24/2015: No significant change observed.					
06/19/2014: A series of scarp erosions have been found on the lower levee slope and at the levee toe. [2016 Site ID:RD0404U01RM42.02]

Downstream view of the erosion.

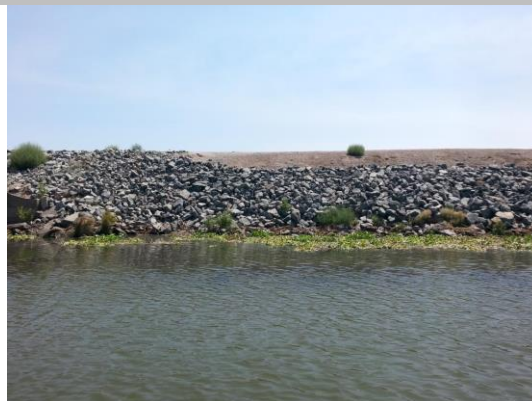
Photo 2 of 2 : SJR2016_RD0404U01RM42.02_3.jpg

Close view of the erosion. The upstream end of the site is protected by riprap revetment.

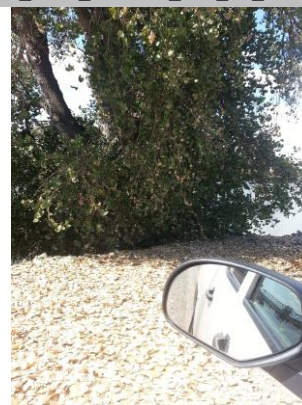
Photo 1 of 1 : FA_2016_RD0404_305_27_20161007_00070.jpg

Looking west at untrimmed trees on waterward slope.

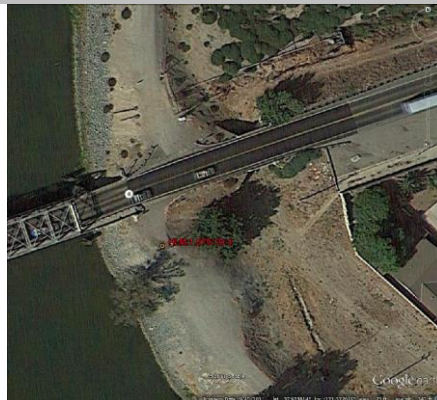
Photo 1 of 1 : UCIP_FA_2016_12386_20062.jpg

LM Start	1.57	Rating **	M	Issue No.	107
LM End	1.57	Issue Type +	En	Location *	CR
Category	Supplemental			GPS Latitude/Longitude	
				Start	End
Item	DWR UCIP Field Study			37.928718 °	37.928718 °
				-121.327206 °	-121.327206 °
DWR ID					
Comment Code					
Inspector Comment					
FS_ID:12386					
DS_ID:17956					
EP_NO: 15562					
Repair Type: Non-Urgent					
Crossing Status: Found					
UCIP Comments: According to Bob Winter of KSN/LMA representative.					
Fiber optics cable goes through levee. No sign/indicators found. And photos not taken.					
FIELD_STRUCT_DESC: 4-inch steel pipe with fiber optics communication cable through levee. Cable Crosses the channel.					
(Permit No. 15562-1991). The pipe is 34 feet below the levee crown.					
FS Date: 3/26/2013

Aerial Photo @HLM=1.5791: No sign posts/markers found.

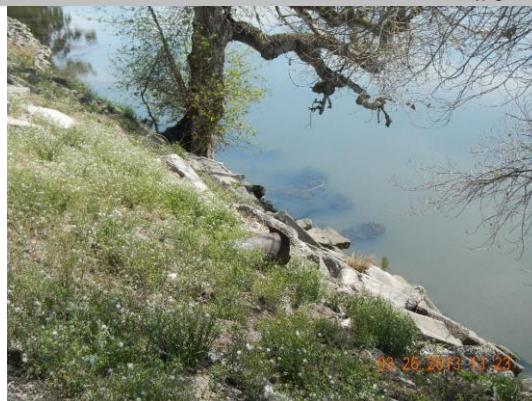
Photo 1 of 2 : UCIP_FA_2016_40487_20064.jpg

WS- steel pipe capped with steel plate.

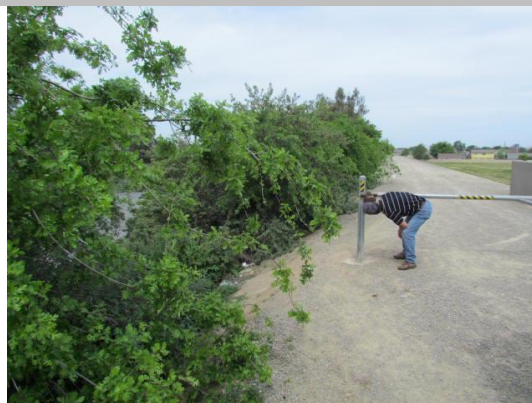
Photo 1 of 2 : FA_2016_RD0404_305_29_20160929_00020.jpg

Looking north at dense vegetation on waterward slope.

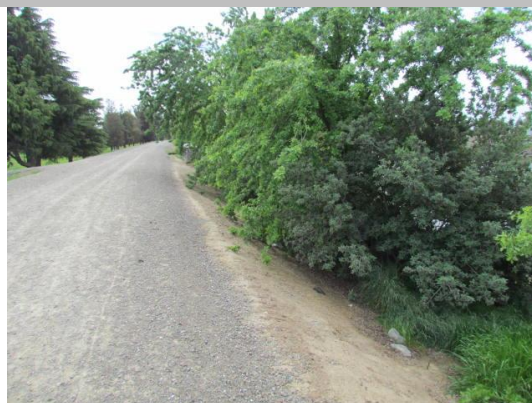
Photo 2 of 2 : FA_2016_RD0404_305_29_20160929_00021.jpg

Looking south at dense vegetation on waterward slope.

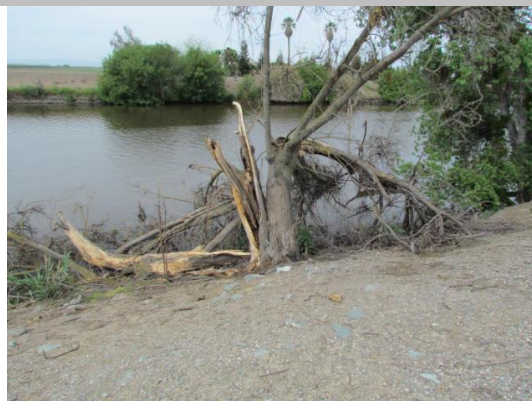
Photo 1 of 1 : FA_2016_RD0404_305_33_20160929_00023.jpg

Looking west at dead tree on waterward slope.

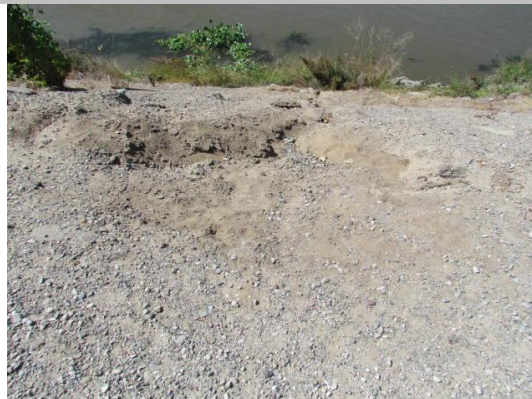
Photo 1 of 2 : FA_2016_RD0404_305_16_20160929_00014.jpg

Looking west at slope damage due to foot traffic.

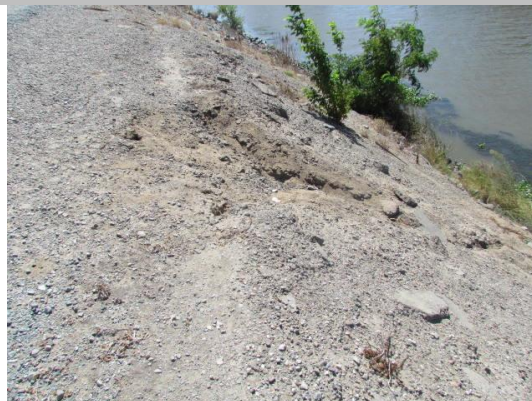
Photo 2 of 2 : FA_2016_RD0404_305_16_20160929_00015.jpg

Looking southwest at slope damage due to foot traffic.

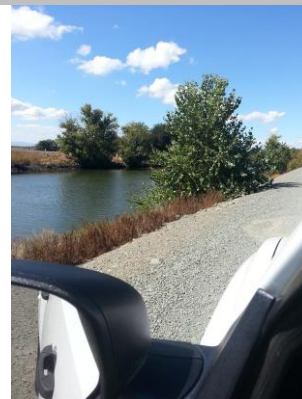
Photo 1 of 1 : FA_2016_RD0404_305_13_20161007_00071.jpg

Looking northwest at untrimmed tree on waterward slope.

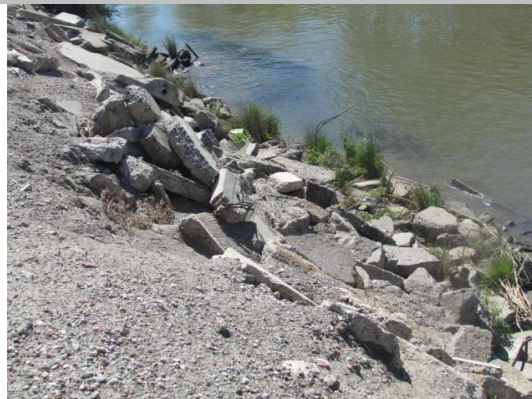
Photo 2 of 2 : FA_2016_RD0404_305_23_20160929_00017.jpg

Looking southwest at concrete rip rap with rebar.

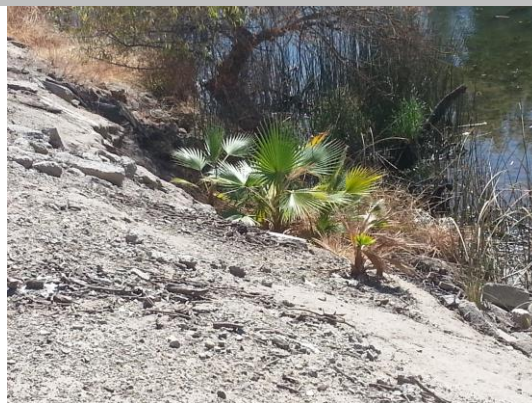
Photo 1 of 1 : FA_2016_RD0404_306_14_20161007_00031.jpg

Looking southeast at erosion on waterward slope.

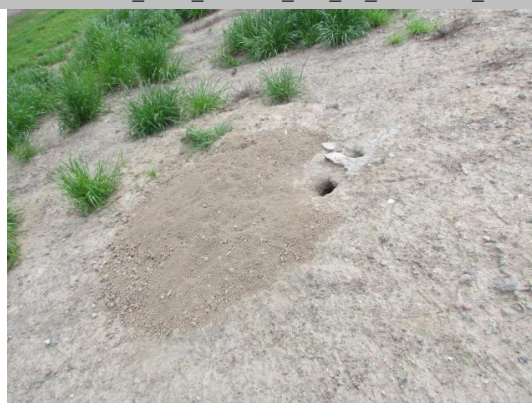
Photo 1 of 2 : FA_2016_RD0404_306_21_20160929_00006.jpg

Looking northeast at large rodent hole on landward slope.

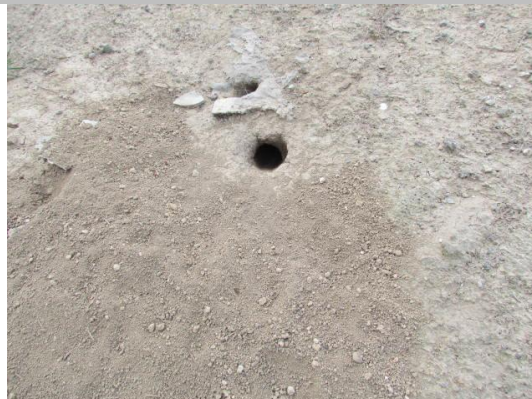
Photo 2 of 2 : FA_2016_RD0404_306_21_20160929_00007.jpg

Looking east at large rodent hole on landward slope.

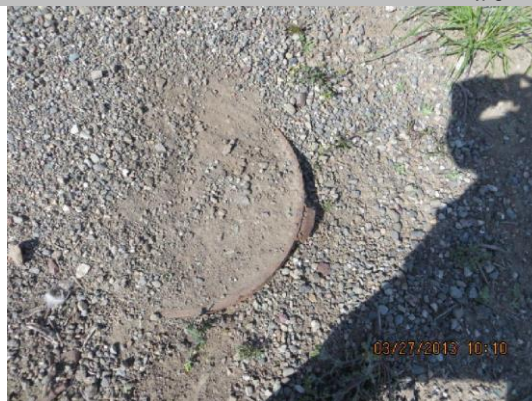
Photo 2 of 2 : UCIP_FA_2016_10908_18181.jpg

WS- damaged, obstructed and buried siphon breaker

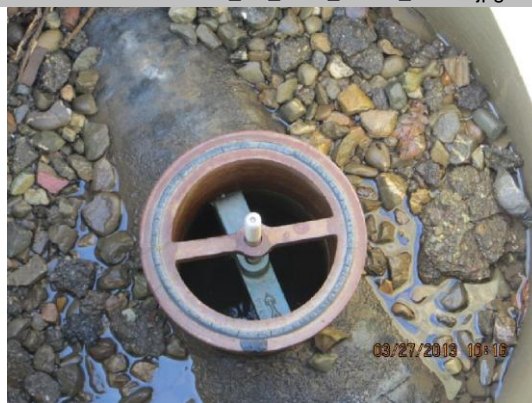
Photo 1 of 2 : UCIP_FA_2016_10945_18248.jpg

WS- siphon breaker without cap in concrete riser

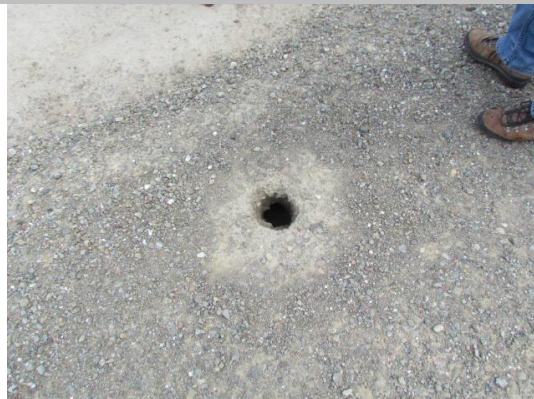
Photo 1 of 2 : FA_2016_RD0404_306_20_20160929_00004.jpg

Looking at rodent hole on levee crown.

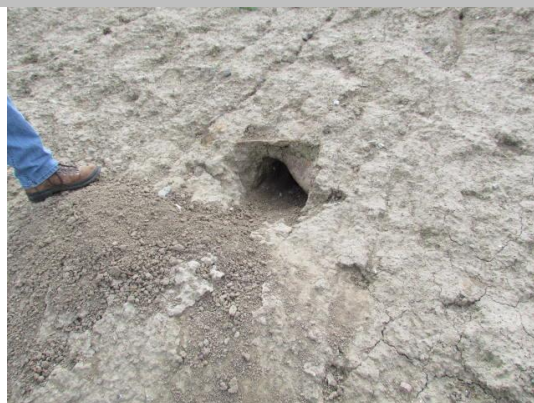
Photo 2 of 2 : FA_2016_RD0404_306_20_20160929_00005.jpg

Looking at rodent hole on landward slope.

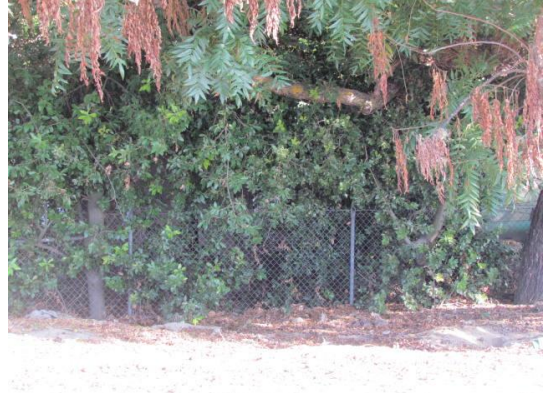
Photo 1 of 4 : FA_2016_RD0404_306_67_20160929_00008.jpg

Looking northeast at dense vegetation inside fenced area near pump station on landside toe.

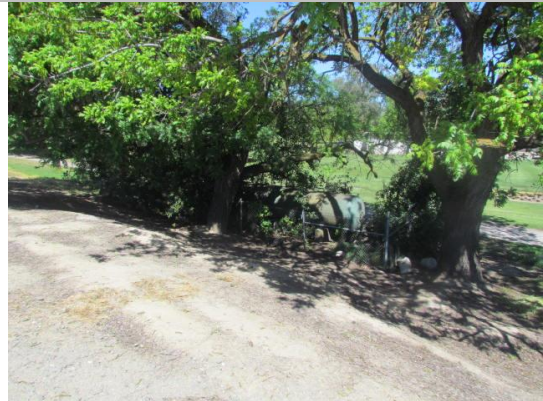
Photo 2 of 4 : FA_2016_RD0404_306_67_20160929_00009.jpg

Looking north at dense vegetation on landward toe around propane tank.

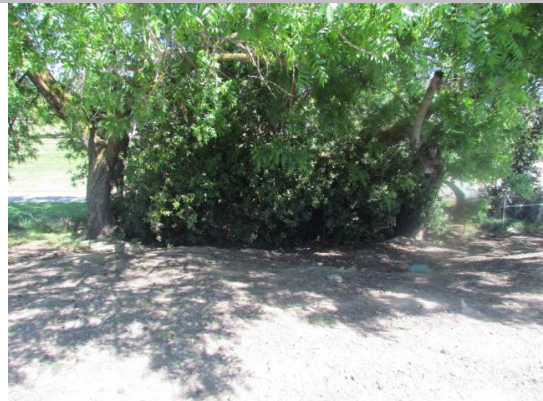
Photo 3 of 4 : FA_2016_RD0404_306_67_20160929_00010.jpg

Looking northeast at dense vegetation on landward toe. (Spring 2013)

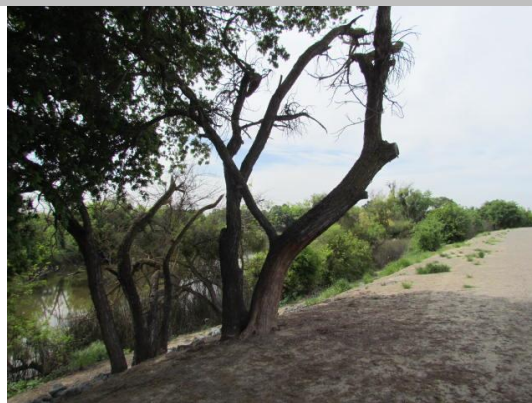
Photo 1 of 2 : FA_2016_RD0404_306_18_20160929_00003.jpg

Looking east at dead trees on waterward slope.

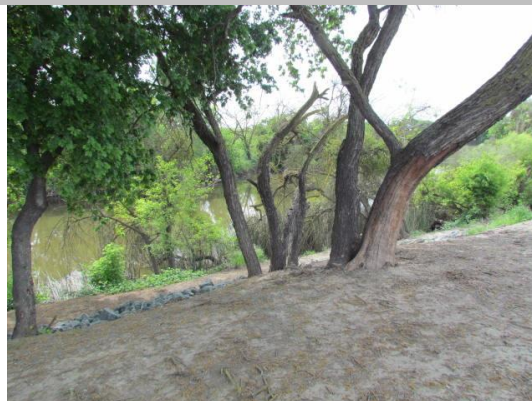
Photo 2 of 2 : FA_2016_RD0404_306_18_20160929_00002.jpg

Looking at close up view of dead trees on waterward slope.

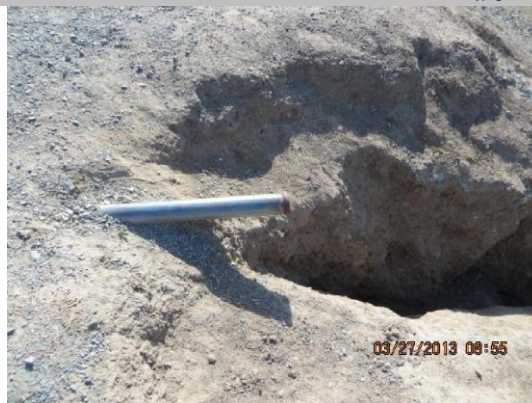
Photo 1 of 2 : UCIP_FA_2016_10853_18134.jpg

WS- capped 3-inch GI pipe

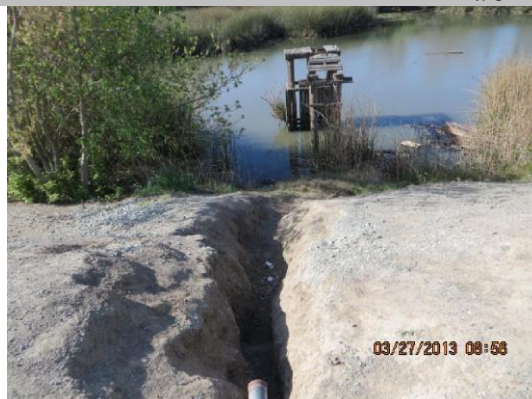
Photo 2 of 2 : UCIP_FA_2016_10853_18133.jpg

WS- soil erosion and gully formation due to leaky pipe

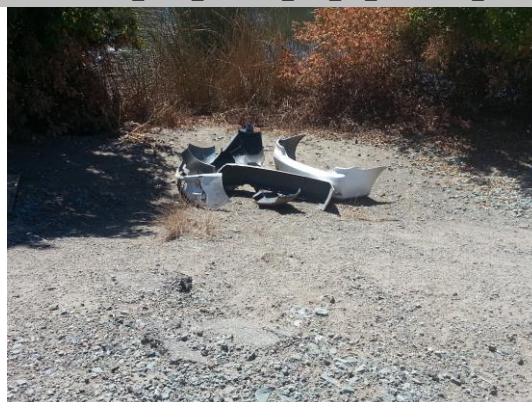
Photo 1 of 2 : FA_2016_RD0404_306_10_20161007_00027.jpg

Looking south at garbage under tree on waterward berm.

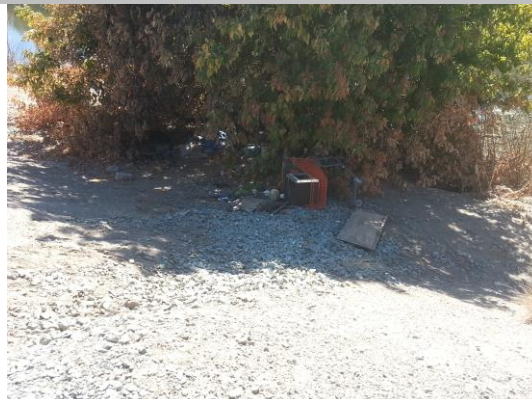
Photo 2 of 2 : FA_2016_RD0404_306_10_20161007_00028.jpg

Looking south at garbage under tree on waterward berm.
